Name of Dam: Fleming Dam

Location: Cumberland County, Commonwealth of Virginia

Inventory Number: VA 04904

PHASE I INSPECTION REPORT

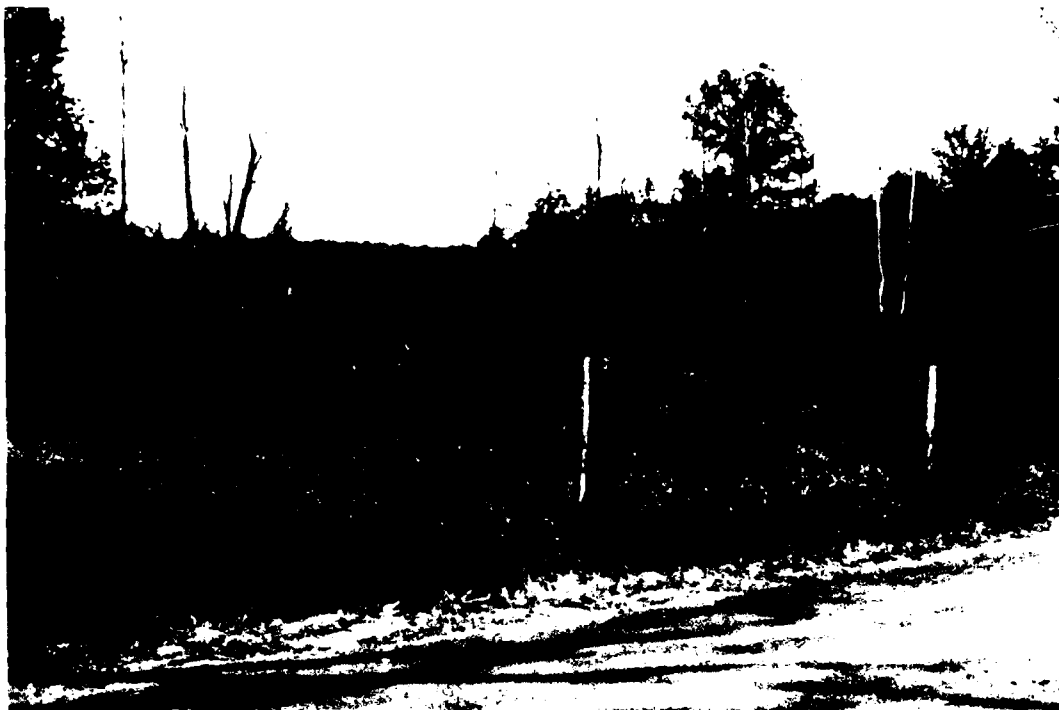
No signs of instability in the dam, such as slumping, tension cracks, or unusual alignment along the crest were detected during the visual inspection. However, the downstream embankment was densely overgrown, which hampered the inspection of that portion of the dam. Numerous large trees were present. Much of the downstream embankment was very steep and irregular in nature, but it was generally not eroded due to the dense overgrowth. The portion of the downstream embankment supported by the stone retaining wall appeared to be stable. The retaining wall itself was in good condition. Numerous animal burrows were observed in the downstream embankment. Although an internal drainage system was apparently lacking, the lower section of the downstream embankment was dry. A few wet areas were noted beyond the toe of the dam, but these areas were considered to be related to poor surface drainage rather than seepage.

**PHOTO 5. Downstream Embankment, Flatter Segment Above Principal
Spillway Outlet**

- 1) Remove the large trees and their root systems from the downstream embankment. The slope should then be regraded with compacted fill.
- 2) Clear the brush and small trees (less than three inches in diameter) from the downstream embankment.
- 3) Backfill the animal burrows and establish a grass cover over the entire embankment.
- 4) Repair the erosion at the junction of the downstream embankment and the left abutment.
- 5) Clean the trash rack at the inlet to the principal spillway.
- 6) Repair the erosion rills in the emergency spillway approach channel.
- 7) Install a staff gage to monitor reservoir levels above normal pool.
